Operating Experience Weekly Summary 97-37

September 5 through September 11, 1997

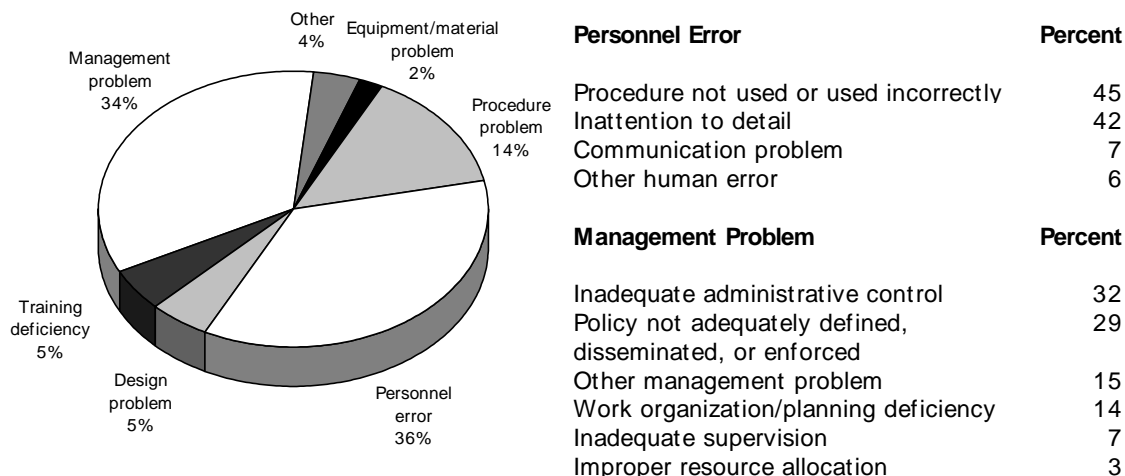
Figure 1-1. Distribution of Root Causes for Alarm Testing and Violations/Inadequate Procedures¹

OEAF engineers searched the ORPS database for reports about alarm testing and procedure violations or inadequate procedures and found 254 occurrences. Figure 1-1 shows the distribution of root causes reported by facility managers for these events. Personnel error represented 36 percent of the root causes; management problems accounted for 34 percent. As shown in the figure, procedure not used or used incorrectly accounted for 45 percent of the personnel errors, with an additional 42 percent attributed to inattention to detail. Inadequate administrative control accounted for 32 percent of the management problems, with an additional 29 percent attributed to policy not adequately defined, disseminated, or enforced.

¹ OEAF engineers searched the ORPS database using the graphical users interface for reports with nature of occurrence code "01F" (violation/inadequate procedures) AND narrative "alarm@ AND test" and found 254 reports. Based on a random sampling of 20 events, OEAF engineers determined that each slice is accurate within ± 1.5 percent.
